# Pedicle screw rupture: A case study

In this work we present a technical description related to the rupture of a titanium alloy pedicle screw and connecting bar implanted in dorsal vertebrae of a patient. Only metallurgical facts are described, with no attempt to identify any imperfections in the clinical aspects related to the rupture. The results described here are based on extensive analysis of the broken materials in a material sciences specialized laboratory. Excluding an incorrect prosthesis implantation in the surgical procedure and a possible low bone density, an information not available to the research team, with high probability the rupture of metallic pieces used in the prosthetic implant, was produced by the low fatigue resistance resulting by an improper machining process and excessive bending of the connecting bar prior to implant.

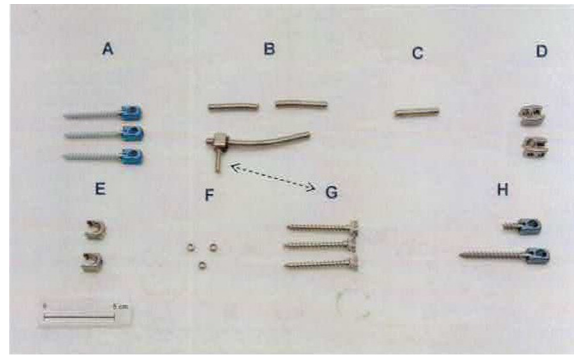
**Fig. 1.** Materials collected for analysis and evaluation (scale: 5 cm). (A) Three new headless screws; relevant parts: (B) connecting bar, broken in two parts; (C) two small fixation bars; (D) two bars fastening heads; (E) two screws fastening heads; (F) three screws fastening nuts; (G) broken screw attached to broken connecting bar; (H) broken screw [26].

After removal and before a new surgical intervention, material extracted from the patient lumbar spine were collected and stored in vacuum and sterile bags for a future evaluation and diagnosis. These materials are shown in Fig. 1.

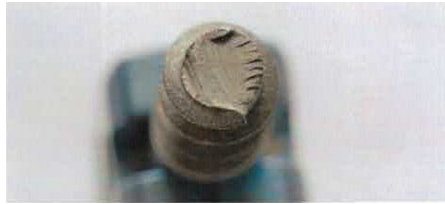
Fig. 2. View of the fracture surface of broken screw [26].

Fig. 2 shows, clearly and without any doubt, that the pedicle screw utilized in the surgical procedure, ruptured by fatigue under alternate flexure, with several points of origin of the fatigue process, under low level of nominal stress. That is, the broken screw showed low resistance to fatigue. Electronic microscopy of this same area validates this hypothesis. About this we shall comment later in this work.

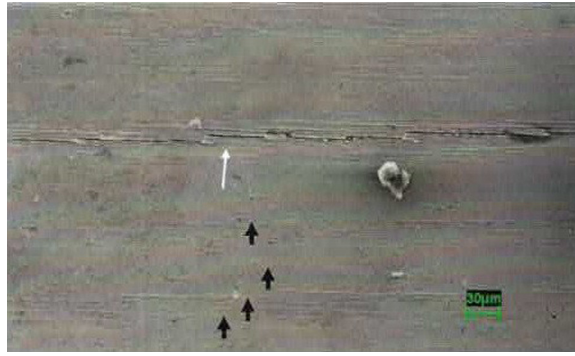
Fig. 10. Secondary crack shown in Fig. 9, identified by a white arrow [26].

Figs. 9, 10 and 13 serve as a clear confirmation of the above reasoning, stressing the hypothesis of a poor machining process. In Fig. 10 it is relevant the fatigue crack close to a coarse machining scratch (black arrows). Figs. 11 and 12 show secondary cracks in the broken screw, showing its fragility in several regions.

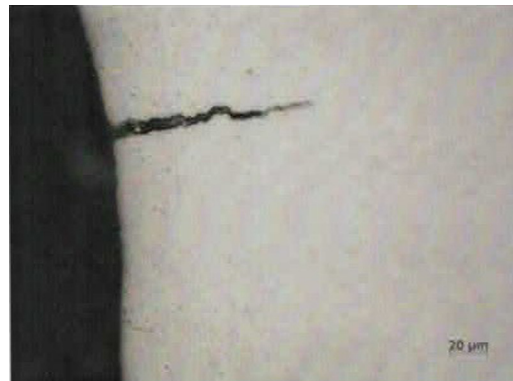
Fig. 12. Metallography. Detail of crack observed in Fig. 11 [26].

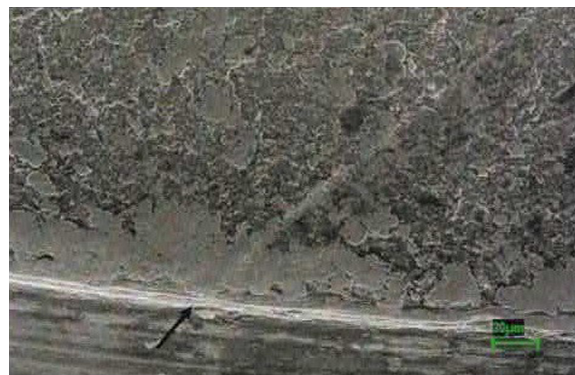
Fig. 14. Ratched marks in the region of fracture origin [26].

of this ratched mark, since with high probability the fatigue crack started at this point and propagated along the entire broken section.
